## Test report

**No. 1061-17**

**Material:** Load-bearing slabs of recycled plastic,  
3 plastic slabs 400 × 400 × 50 mm

**Subject:** Performance of load tests  
with deformation measurement

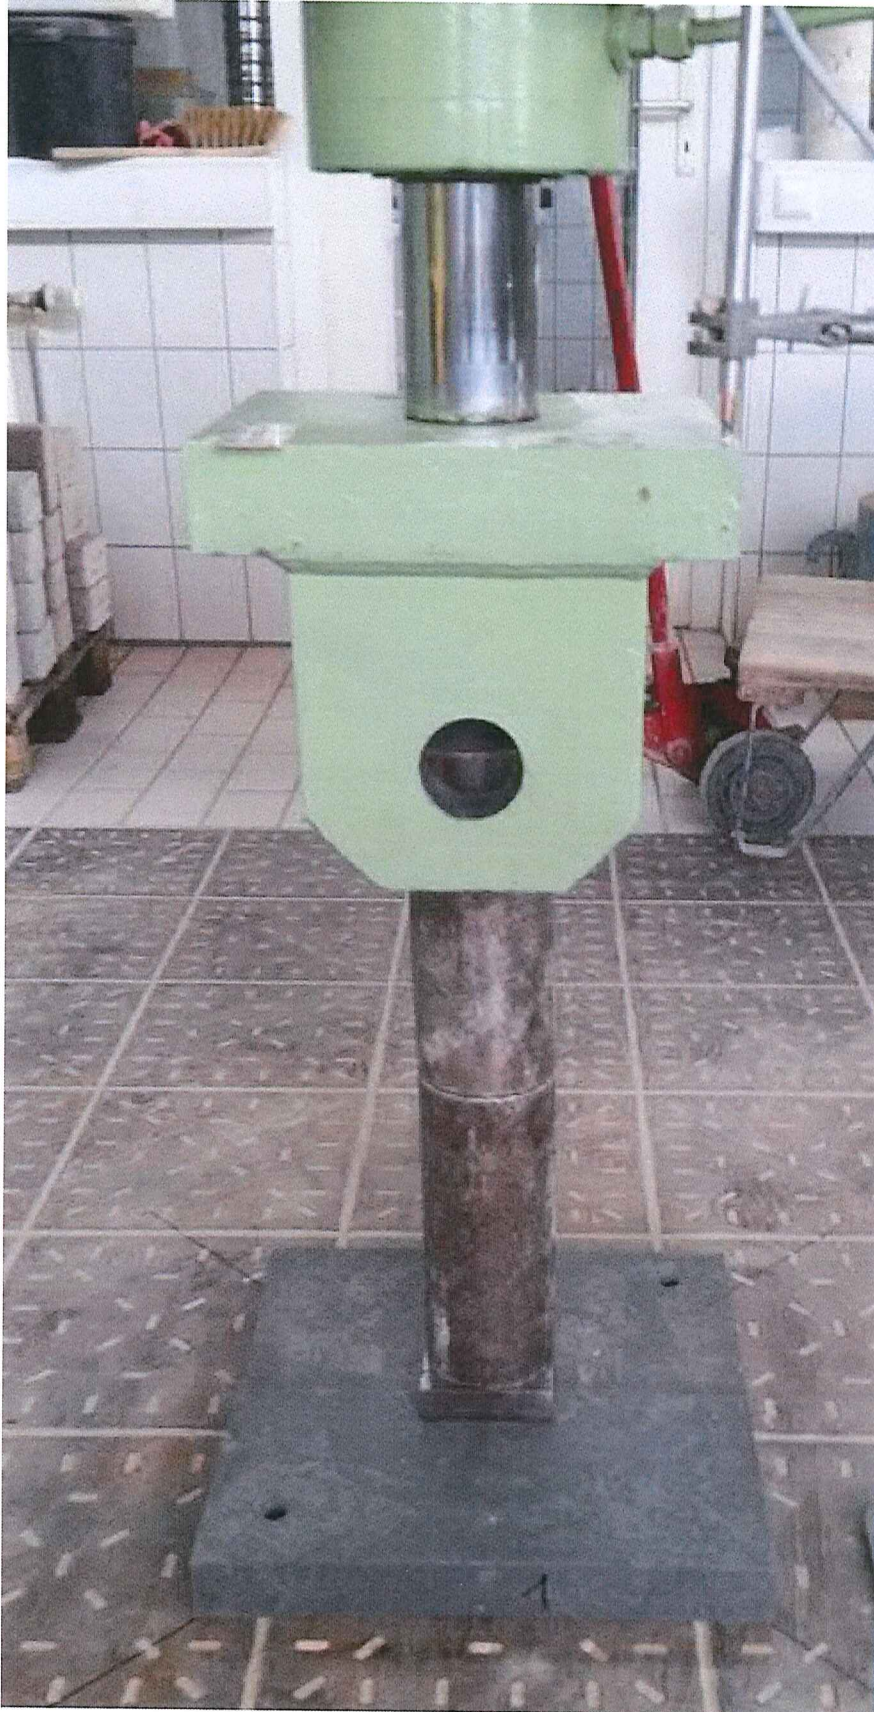
The test was conducted in a vertex pressure testing machine with a testing velocity of 5 mm/min. The load was transferred to the plastic slab by means of a steel plate with a side length of 100 mm. The 50 mm thick slabs were tested on a rigid support of steel tiles. The following figure illustrates the test setup.

Figure 1: Load test with rigid support

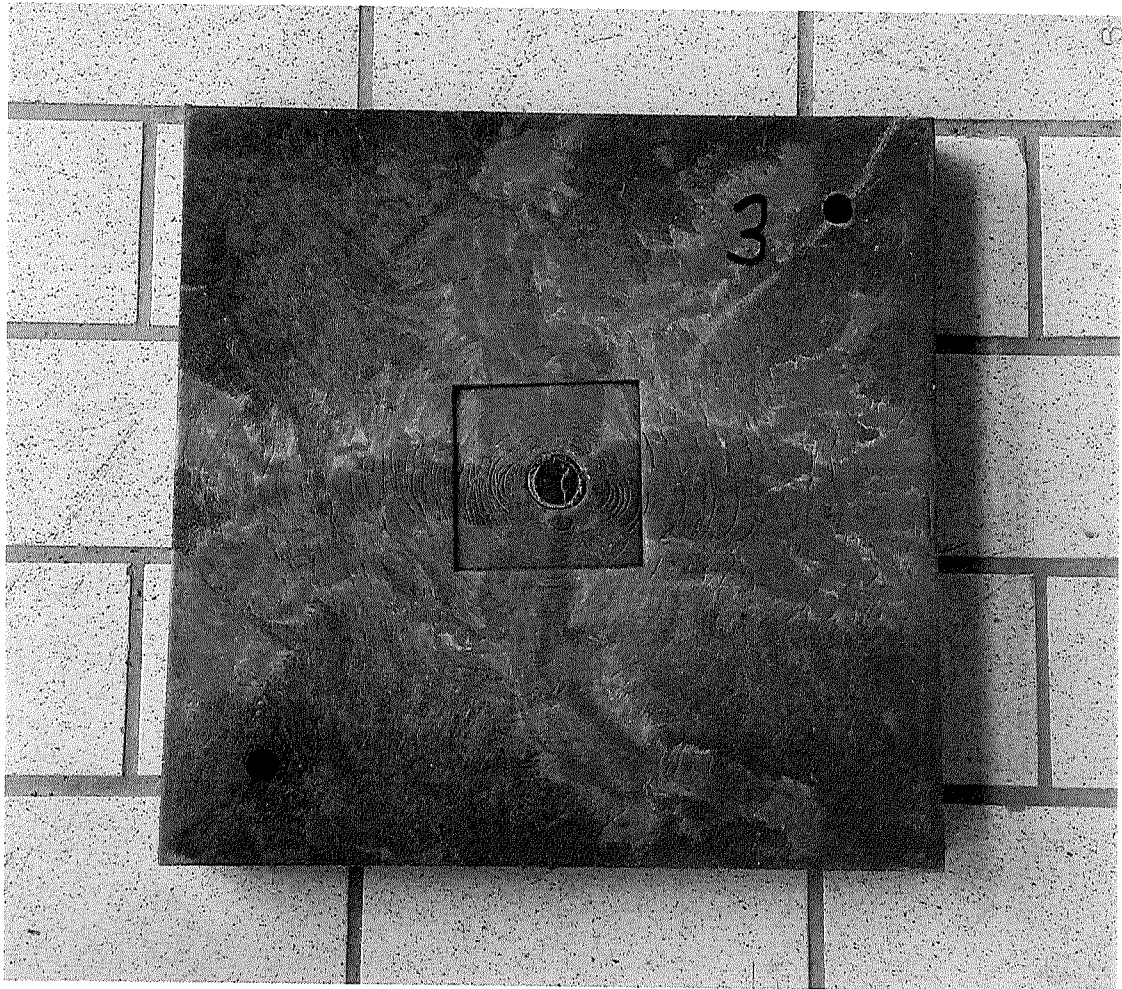
The following figure exemplary shows the deformation resp. breakage pattern of the slabs after the end of the test.

Figure 3: Plastic slab, thickness 50 mm, following the test on rigid support. Clearly visible: indentation of the load slab in the middle of the tested piece.

When testing the slabs on a rigid support and given a breaking strength of 400 kN there was no breakage. At the same time, a plastic deformation of the slabs of 14.4 mm, 10.8 mm and 12.7 mm was measured.
